HISTORIC PROPERTY INVENTORY FORM

Field Site No. 303-A OAHP No. _____ Date Recorded 17 Oct 1994
Site Name Historic Magazine Product Storage Revised 28 May 1998
Common Storage Building
Field Recorder K.A. Simmons, M.E. Crist, I.C. Lindsay, J.K. Keating
Owner's Name U.S. Department of Energy, Richland Operations Office
Address P.O. Box 550
City/State/Zip Code Richland, WA 99352

Hanford Site Manhattan Project and Cold War Era Historic District

Building 303-A, 300 Area

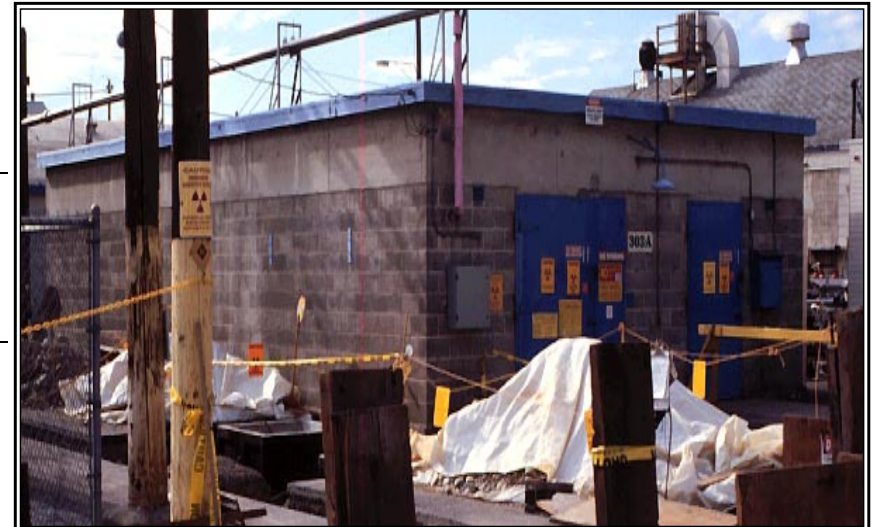
Photo at right; Roll 180, Frame 11
view of north and east facades

The 303-A Storage Building is a single story, one room, concrete structure, measuring 48 feet long (N-S) by 27 feet wide (E-W). Total area covers 1,296 ft². The walls change from concrete block to poured concrete three quarters of the way up each wall. The south facade has a single, metal entrance door with a louver located at its bottom. On the west facade is a small, fluted metal addition with a single, metal door. The north facade has two doors; one is a single, metal door with an original light fixture extending over it. The other door is an unevenly split double door. There are two 8-inch round metal vents extending from the concrete at ground level on the east facade and two 8-inch vents extending from the concrete at ground level on its west facade. The roof is covered with tar and gravel and supported by reinforced concrete beams. There are no visible architectural modifications to the structure.
